CASE STUDY

TOPIC: Varnish Contamination In Large Hydraulic Shear

LOCATION: Salt Lake City, UT

DATE: May 24, 2016

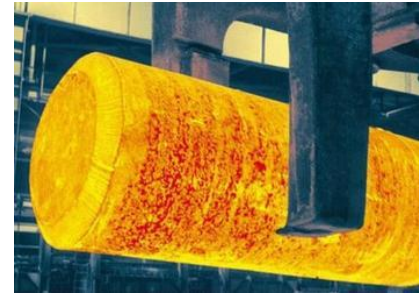
Problem: Operators of a large Hydraulic Shear noticed elevated temperatures and a discoloration of the oil in their 2,500 gallon hydraulic oil system. This prompted them to conduct oil analysis, and the lab results revealed an elevated varnish potential number of MPC 49. If left untreated, the operators were worried that varnish would eventually cause premature failure of the large Hydraulic Shear, requiring costly repairs and down-time.

Solution: To effectively mitigate the varnish contamination in the hydraulic oil, the plant decided to implement a 10 GPM Varnish Removal System utilizing Granular Adsorbent Media and High Efficiency Beta>1000 Filter Elements to re-circulate the reservoir in a kidney-loop configuration, continuously removing impurities as the hydraulics of the Shear were actuated.

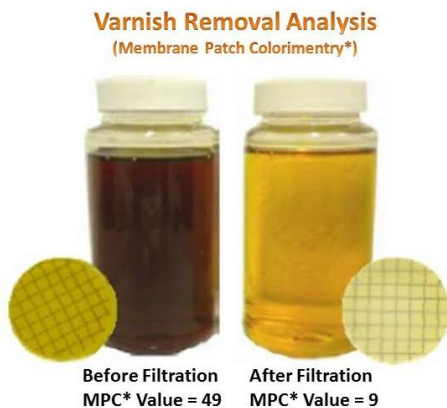
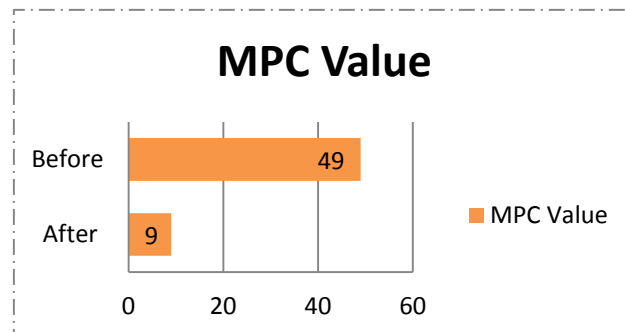
Results: The starting varnish content in the oil was MPC 49. After approximately 6 weeks of run-time, the varnish potential dropped significantly to MPC 9.
